## ASSESSMENT AND REPAIRMENT OF THE REINFORCED CONCRETE STRUCTURES DAMAGED DUE TO RUSSIAN MISSILE ATTACK

The object of research – load bearing structures damaged due to blast exposure of missile strike by the armed forces of the Russian Federation.

The purpose of the research is to determine the actual technical state of the building's load-bearing structures; to check ability to repairment of the building.

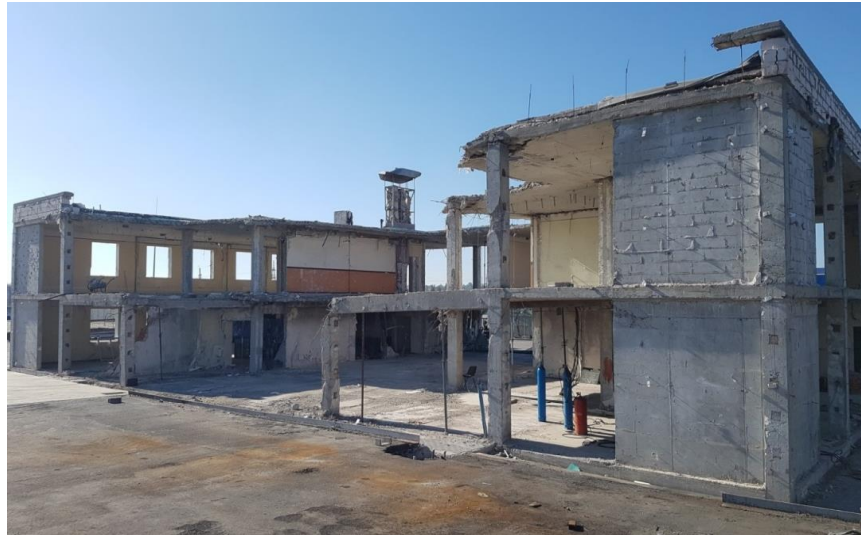
The investigated building was partially collapsed as a result of a blast exposure due to

missile attack by the armed forces of the russian federation in May 2022. The epicentre of the explosion was located right next to the building, at a distance of up to 10 m from the external wall. According to witnesses, the shell-hole

was up to 8 m in diameter and up to 4 m in depth. Neighbouring buildings were also heavily damaged.

**Fig. 2.** General view of the partially collapsed building

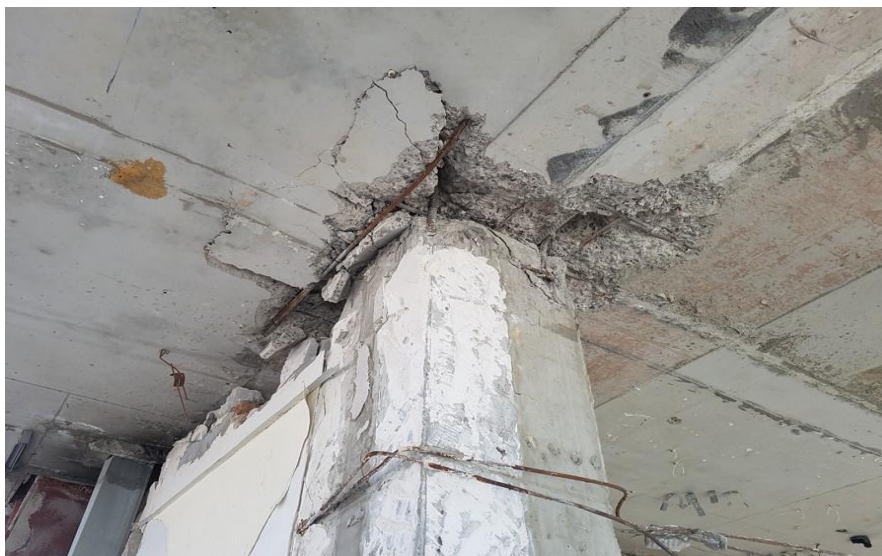
Mechanical damages such as concrete fractures, baring, deformations, ruptures, visual elongation of steel rebars was recorded during the examination of 1st and 2nd floor columns of

the building. A numerous columns had damages located in the upper punching zone of floor slabs (Fig. 3).

**Fig. 3.** Concrete fractures of columns at punching zone of floor slabs

| N o. | Type of damage | Measures to repairing structural elements |
|---|---|---|
| 2. | Concrete fractures at punching zone of floor slabs | |

| N o. | Type of damage | Measures to repairing structural elements |
|---|---|---|
| 1. | Concrete fractures, baring of steel rebars, vertical deflections | Demolishment and replacement of damaged structural elements |

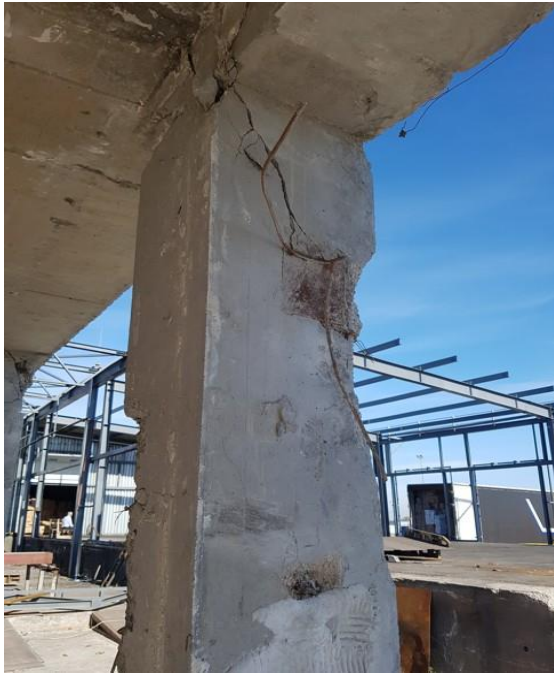
1st floor columns 2-3/G and 3rd floor columns 1-2/A had vertical deflections

(Fig. 4, 5). Significant concrete fractures, baring of steel rebars, and cracks with a width

**Fig. 4.** Concrete fractures of columns  
**Рис. 4.** Руйнування бетону колон

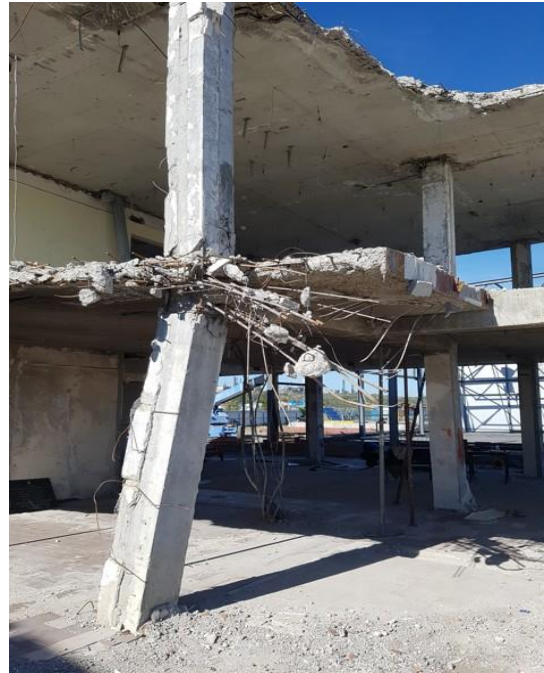
**Fig. 5.** Vertical deflections of concrete columns  
**Рис. 5.** Вертикальні переміщення колон

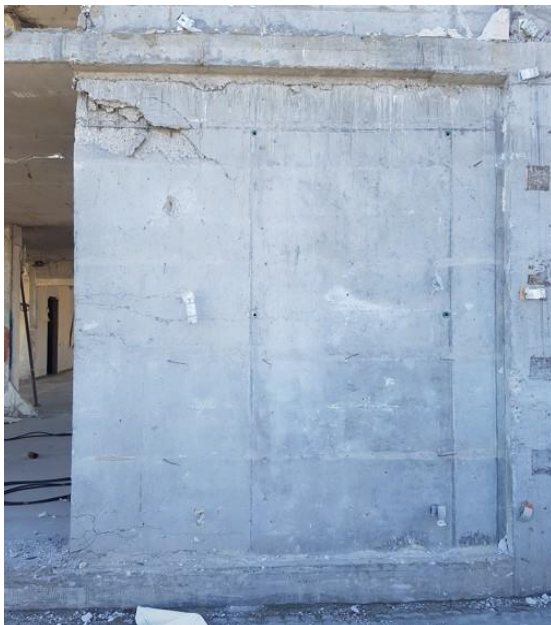
of more than 2mm were recorded during the examination of the shear walls. The concrete

fractures of the shear walls is located in the upper punching zone of floor slabs (Fig. 6, 7).

**Fig. 6.** Concrete fractures of shear walls  
**Рис. 6.** Руйнування бетону стіни

| N o. | Type of damage | Measures to repairing structural elements |
|---|---|---|
| 4. | Concrete fractures, baring of steel rebars, vertical deflections | Partial demolishment and replacement of damaged structural elements |

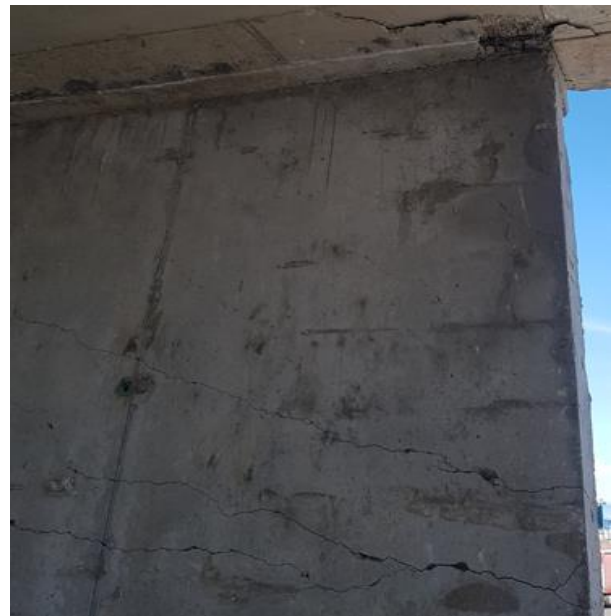
**Fig. 7.** Wall with cracks more than 2mm wide  
**Рис. 7.** Стіна із тріщинами понад 2 мм

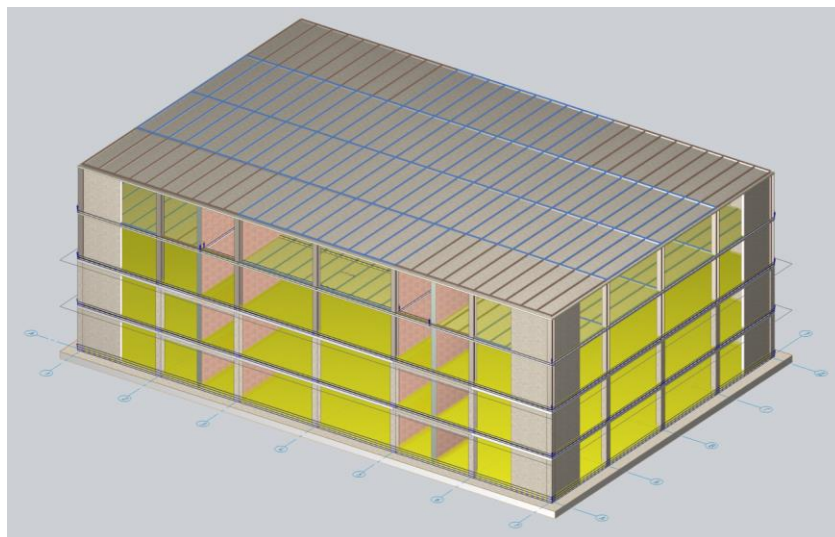
**Fig. 8.** The restoration scheme with a superstructure made of steel structures

- without a superstructure – 1138 kN;
- with 2-story reinforced concrete superstructure – 2100 kN;
- with 2-story superstructure made of steel structures – 1942 kN. The minimum values of columns' load-bearing capacity ratio were:
- without a superstructure – 1,15 (reserve is 15%);
- with 2-story reinforced concrete superstructure – 0,78 (deficient load-bearing capacity);
- with 2-story superstructure made of steel structures – 0,84 (deficient load-bearing capacity).

According to the results of the structural analysis of different restoration schemes and national regulations [9-11] conclusion about the possibility of 2-story superstructure made of steel structures without strengthening the foundation was made. In addition, columns and shear walls have to be strengthened. The punching shear zones of floor slabs also have to be strengthened.
