TECHNOLOGY FOR RESTORING STRUCTURES OF MULTI-APARTMENT PANEL BUILDINGS DAMAGED BY MILITARY ACTIONS

Abstract. This paper addresses the problem of restoring the load-bearing structures of multi-apartment large-panel residential buildings damaged as a result of military actions, based on a real case study. The nature of structural damage caused by blast effects is analyzed, including the displacement and destruction of wall panels, loss of stiffness in structural joints, damage to floor slabs, and disruption of the building's spatial behavior. It is shown that the main hazard is associated not only with local structural failures, but also with the loss of composite action between the elements of the structural system.

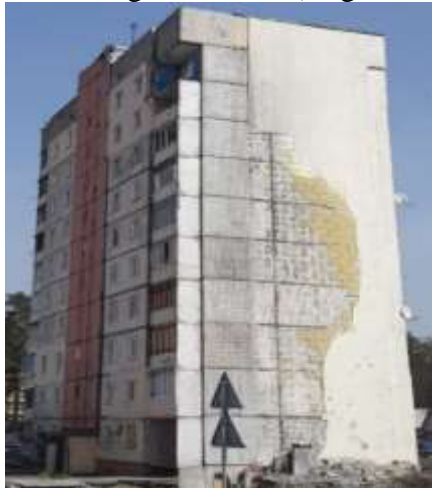
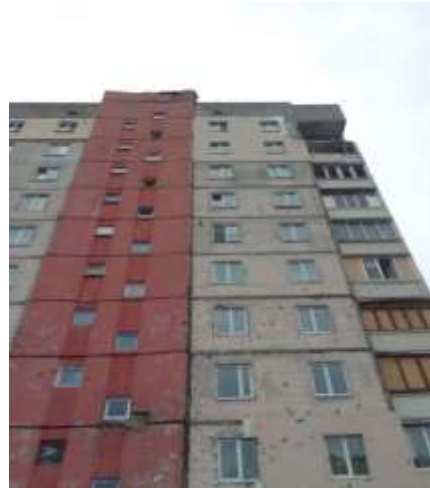
The 10-storey panel residential building consists of a single section (single-entrance

Fig. 1 Panel residential building damaged during military actions. Photo by Dmytro Levkivskyi

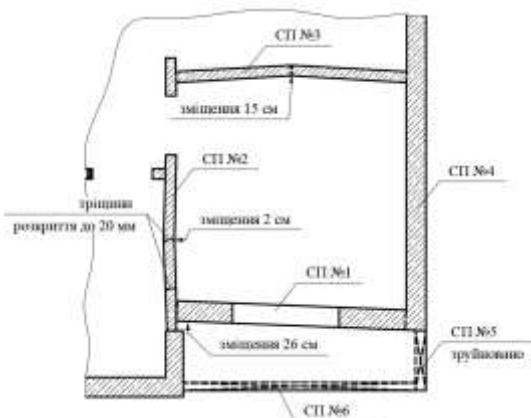
Fig. 2 Plan of the damaged room, Apartment No. 40, 10th floor

2. Wall panel No. 2 was displaced by 2 cm, resulting in the formation of two vertical cracks with an opening width of up to 20 mm (Fig. 2).
3. Wall panel No. 3 fractured in the middle under the effect of the blast wave and was displaced by 15 cm (Fig. 4). The panel contains weakened zones in the form of channels for electrical networks located in the middle of the slab, which contributed to the development of failure in this area.
4. Balcony wall panel No. 5 and enclosing panel No. 6 were destroyed (Fig. 5).

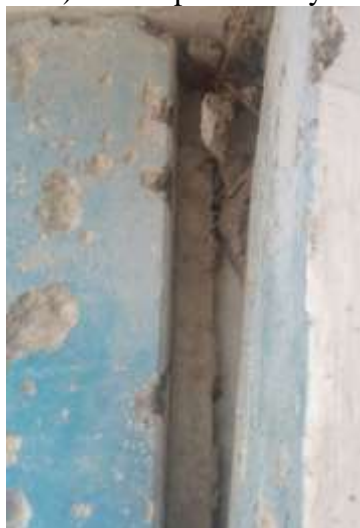
1. The shell damaged wall panel No. 1 (Fig. 2) and displaced it by 26 cm (Fig. 3) into

Fig. 3 Damaged wall panel No. 1, displacement of 26 cm (view from the balcony side).

the room, causing the floor slab and wall panel No. 2 to lose their structural restraint.

At the next stage, wall panel No. 1 was dismantled (Fig. 15), and a steel frame made of Channel No. 16 and 125×8 and 100×8 angle sections was installed. The space between the steel elements was filled with 300 mm thick aerated concrete blocks (Fig. 16).

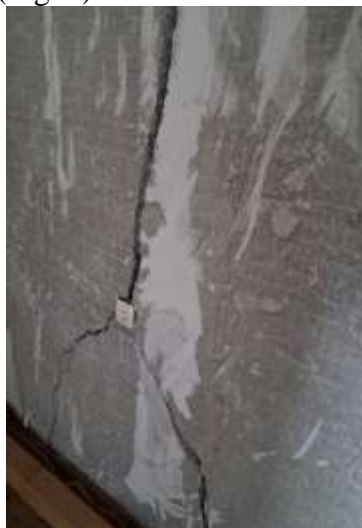
Fig. 4 Damaged wall panel No. 3.

Vertical through-cracks (view from the room side). Photo by Dmytro Levkivskyi

After the restoration of wall panel No. 1, works were carried out to restore wall panel No. 3. In the preliminary design, it had been planned to cut out a portion of the wall around the cracks, lift and level the floor slab, and pull the parts of the wall panel back into their design position using threaded rods. However, this concept proved technologically unfeasible and was not implemented. As a result, a decision was made to dismantle the wall and introduce a steel frame similar to that used for wall panel No. 1 (Fig. 17).

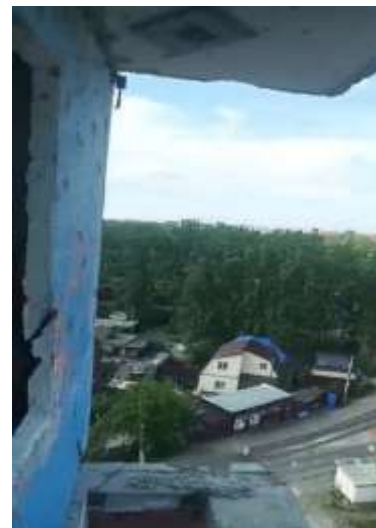
Fig. 5 Destroyed wall panels No. 5 and No. 6 on the balcony. Photo by Andrii Zabrodskyi

After strengthening the floor slab, the destroyed balcony panels No. 5 and No. 6 were replaced by installing a steel frame made of angle sections beneath the slab and reconstructing a brick wall in place of the destroyed reinforced concrete panel (Figs. 12, 13).

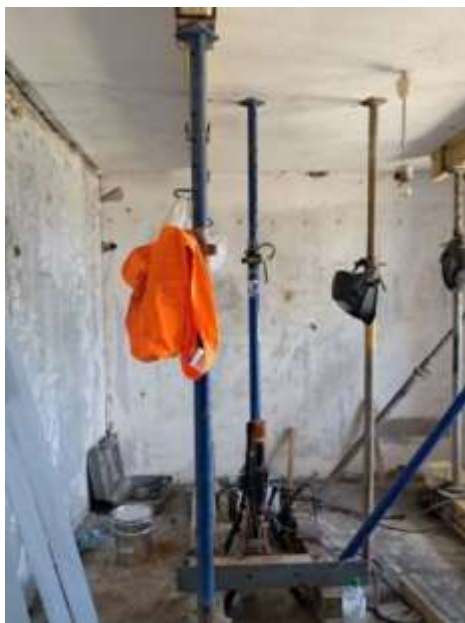
5. The cantilever floor slab above the balcony experienced significant deflection, and an 8 cm gap formed between it and the façade wall, creating an emergency condition (Fig. 5).
6. The blast wave lifted the floor slab of the technical floor, tore out the embedded connections, and caused diagonal cracks to form throughout the slab, making its normal operation impossible (Fig. 6).
7. The floor slab between the 9th and 10th floors sustained similar damage.

Fig. 6 Diagonal cracks in the floor slab.
Photo by Andrii Zabrodskyi
Рис.6 Діагональні тріщини в плиті
перекриття.
Автор фото Андрій Забродський

The remaining task is to strengthen the floor slab between the 9th and 10th floors, which was affected by the explosion and exhibits significant cracks and deflections. A decision was made to introduce a system of cast-in-place reinforced concrete beams (Figs. 18, 19, 20).

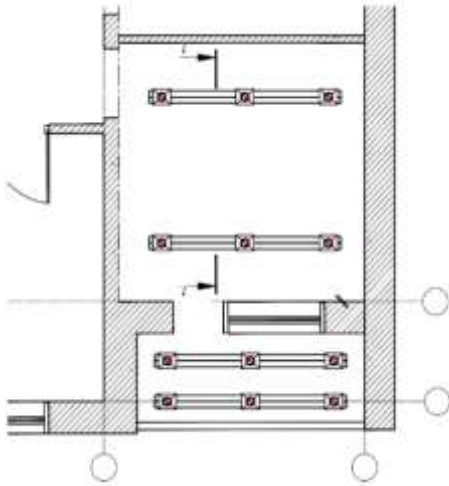
Fig. 7 Layout of the shoring prop system
Рис.7 Схема влаштування системи опалубочних стійок

Therefore, a system of shoring props was first installed according to the scheme (Fig. 7) on the 10th, 9th, and 8th floors in order to stabilize the floor slabs and ensure the safety of the construction workers.

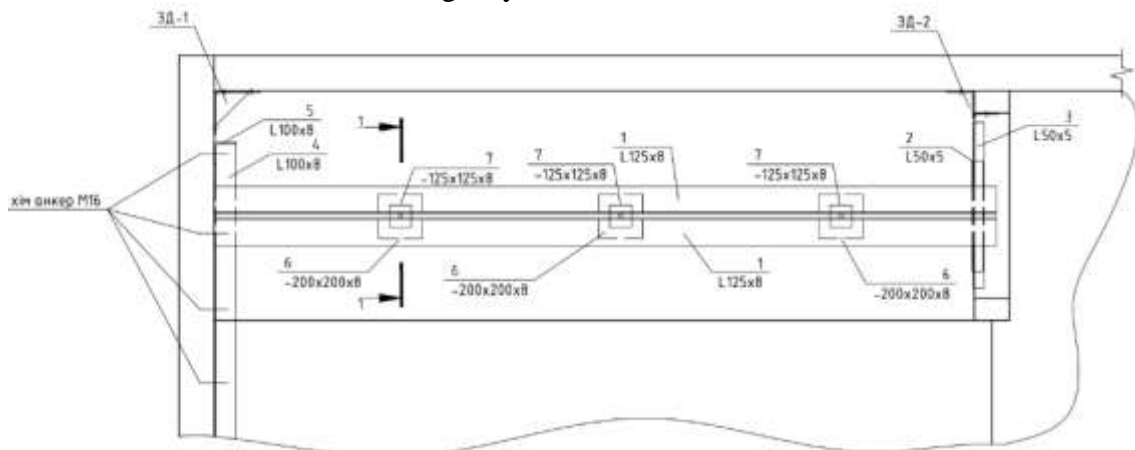
Fig. 8 Scheme for lifting and leveling the balcony slab
Рис.8 Схема виважування плити балкону

At the next stage, a scheme was developed for lifting and leveling the cantilever balcony floor slab (Fig. 8), which had tilted by 8 cm. For this purpose, a steel beam made of paired 125×8 angles was installed on the technical floor using an M16 threaded rod system, as shown in Fig. 9.

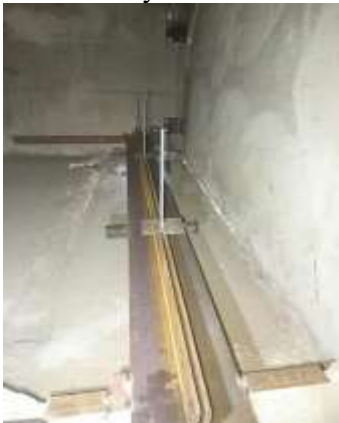
Fig. 9 Scheme for lifting and leveling the balcony slab: steel beam made of paired 125×8 mm angles.

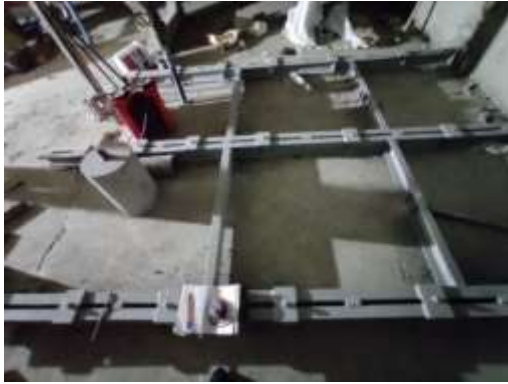
Fig. 10 Scheme for strengthening the floor slab between the 10th floor and the technical floor. Photo by Andrii Zabrodskyi

To ensure safe occupancy of the room during the dismantling of the destroyed walls, the floor slab between the 10th floor and the technical floor was preliminarily strengthened by introducing a system of steel beams, which were engaged structurally by means of M16 threaded rods and steel plates (Figs. 10, 11).

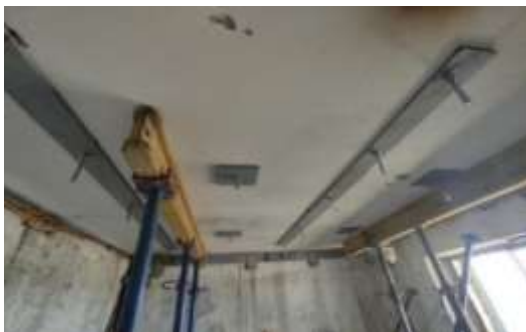
Fig. 11 Scheme for strengthening the floor slab between the 10th floor and the technical floor.

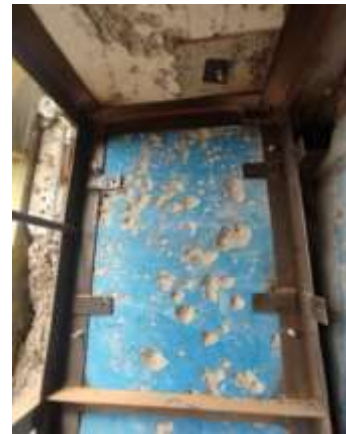
Fig. 12 Steel frame for the restoration of the balcony structures. Photo by Dmytro Levkivskyi

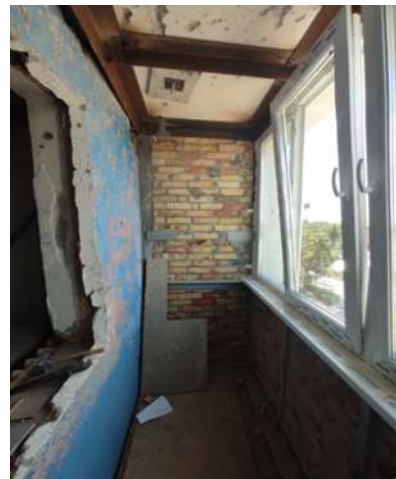
Fig. 13 Steel frame for the restoration of the balcony structures. Photo by Dmytro Levkivskyi

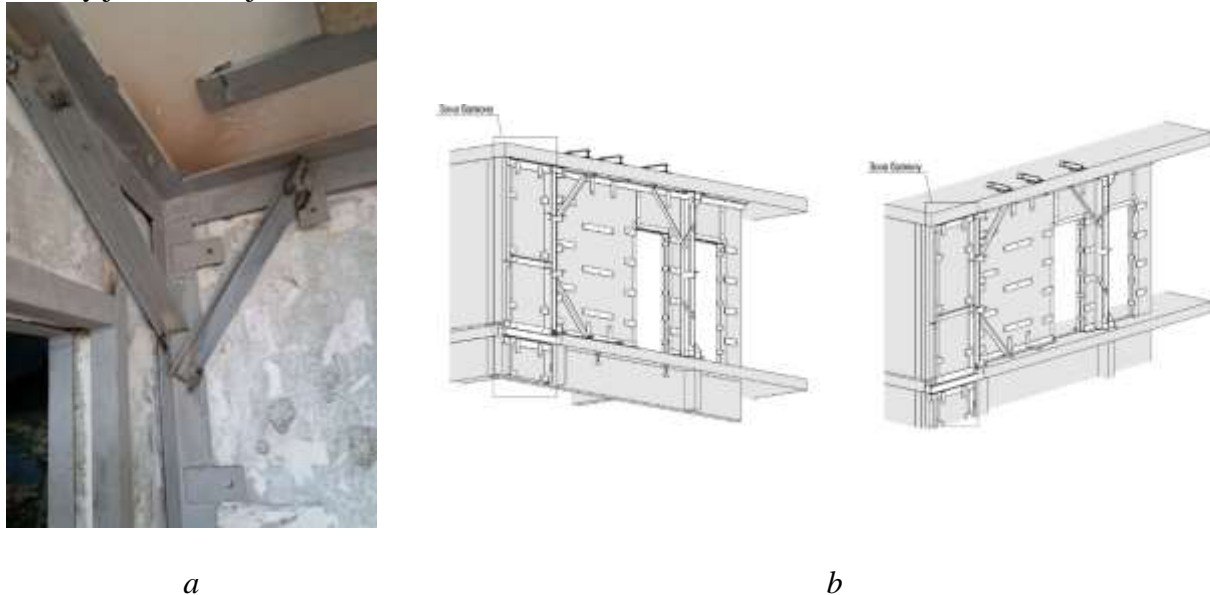
Fig. 14 Installation of the safety frame in the room: a - actual view (photo of implementation); b - schematic diagram of the structure.

panels and to redistribute internal forces. Along the perimeter of the room, a framing system made of 125×8 and 100×8 angle sections was installed. These elements were anchored to the reinforced concrete components using M16 chemical anchors, while some of the elements were temporary due to the distorted geometry of the room walls (Fig. 14).

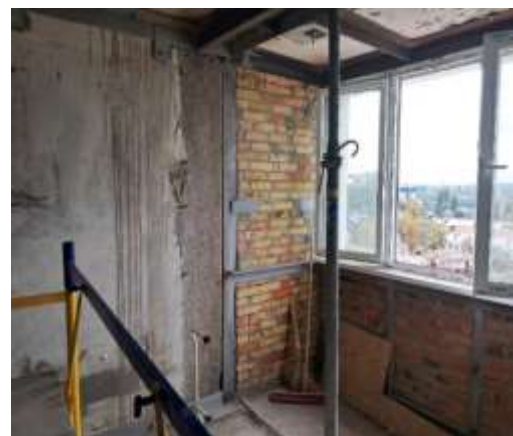
Fig. 15 Dismantled wall panel No. 1.

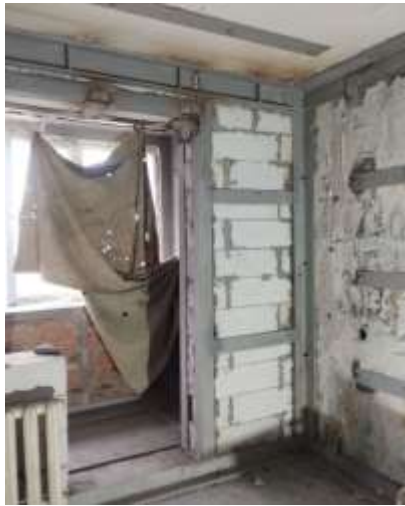
Fig. 16 Restoration of wall panel No. 1.

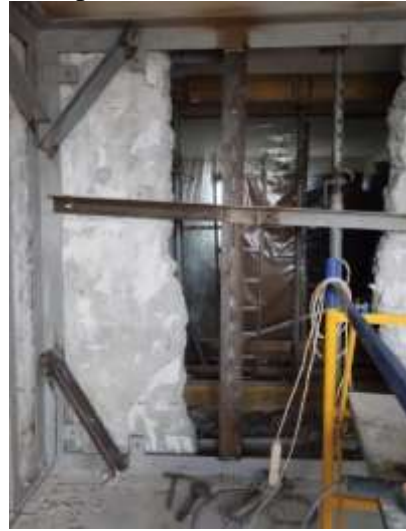
Fig. 17 Dismantling of wall panel No. 3.

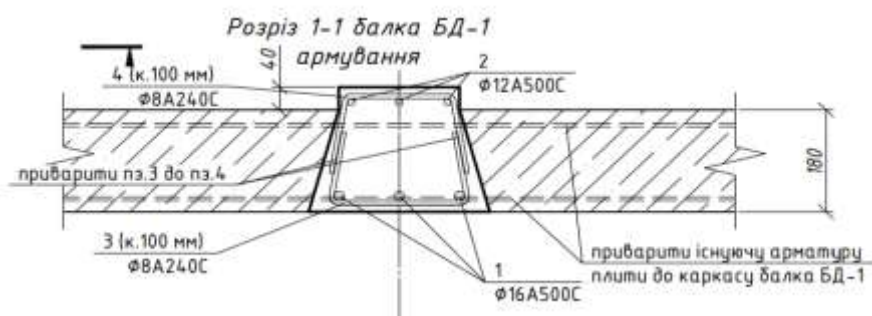
Fig. 18 Introduction of cast-in-place reinforced concrete beams into the floor slab

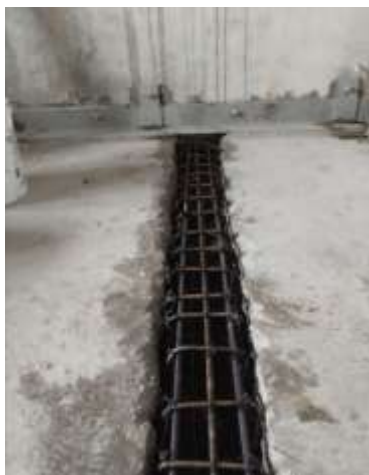
Fig. 19 Reinforcement of the cast-in-place beam.
Photo by Dmytro Levkivskyi
Рис.19 Армування монолітної балки. Автор
фото Дмитро Левківський

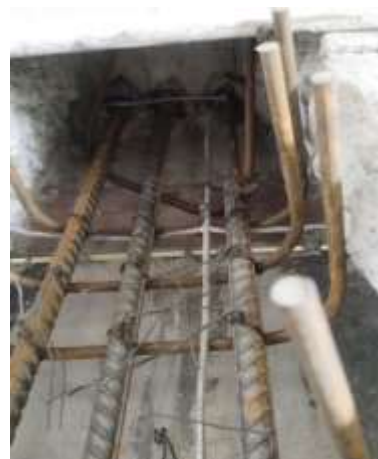
Fig. 20 Reinforcement of the cast-in-place beam.
Photo by Dmytro Levkivskyi
Рис.20 Армування монолітної балки.
Автор фото Дмитро Левківський
