## CHANGING IN THE STRESS-STRAIN STATE WITH NON-UNIFORM DAMAGED REINFORCED CONCRETE

**Abstract.** This article considers the influence of local one-sided damage on the stress-strain state of a reinforced concrete beam. The research is aimed at analyzing changes in load-bearing capacity, deformations, and potential failure mechanisms caused by unilateral damage. Reinforced concrete is one of the most widespread and important construction materials used in various engineering structures, from residential and public buildings to bridges and other infrastructure facilities. However, despite its high durability and significant reliability, reinforced concrete may undergo substantial damage under the influence of various aggressive environmental factors [1].

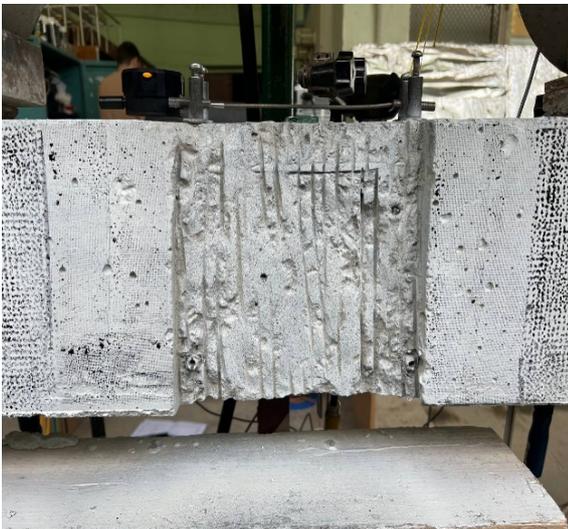
Load control was performed using dynamometers, and the load was applied incrementally in steps of 10% of the expected load-bearing capacity. This setup allows for the creation of a constant pure bending region in the central part of the beam and ensures a more uniform distribution of internal forces. To simulate localized damage caused by one-sided wetting, a defect measuring 200×200×30 mm was made on the side surface of the beam in the pure bending zone (Fig.1).

The damage was introduced prior to the beginning of the loading process.

**Fig. 1.** General view of the damage  
**Рис.1.** Загальний вигляд пошкодження

This damage simulates conditions in which reinforced concrete is exposed to prolonged moisture from one side, a scenario typical of many real operating environments, such as water infiltration or cycles of freezing and thawing. Such exposure leads to delamination of the concrete layer, increased deformations and cracking, and, as a consequence, to a reduction in load-bearing capacity, a change in the inclination of the neutral axis, and an alteration of the stress-strain state that deviates from the design assumptions. For the experimental procedure, three-dimensional digital image correlation (3D-DIC) was used on the damaged side of the reinforced concrete

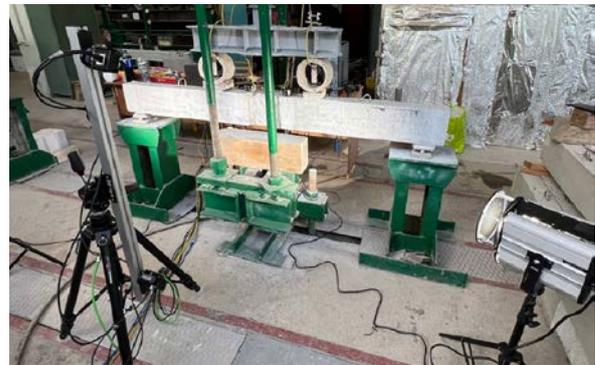
beam. This system allows for precise tracking of displacements and deformations on the specimen surface during loading (Fig. 2).

**Fig. 2.** View from the damaged side  
**Рис.2.** Вигляд із сторони пошкодження.

To implement digital image correlation, a system consisting of four cameras was used: two of them were oriented to capture the entire length of the beam, while the other two focused on the pure bending zone for detailed analysis of deformations in this critical area.

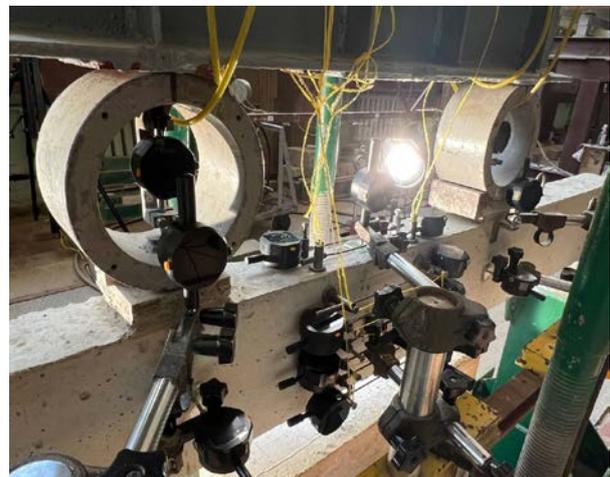
On the opposite side of the reinforced concrete beam, deformations were measured using micro-indicators (Fig. 3), which provided wireless data transmission to a personal computer in real time.

**Fig. 3.** Placement of the micro-indicators.  
**Рис.3.** Схема розташування мікроіндикаторів

The instrument layout provided for the installation of the first micro-indicator at a height of 20 mm from the top edge of the beam, while the remaining sensors were mounted at 30 mm intervals along the height of the cross-

section. To monitor horizontal displacements deflection micro-indicator were installed on the side surface of the beam in three zones: ts of the study showed that the presence of localized damage leads to a reduction in the load-bearing capacity of the beam compared to the reference undamaged beam, as confirmed by both numerical and experimental data presented in the article [24]. Notably, significant horizontal displacements of the beam were recorded during the experiment. This behavior indirectly under the points of load application and in the central part of the span.

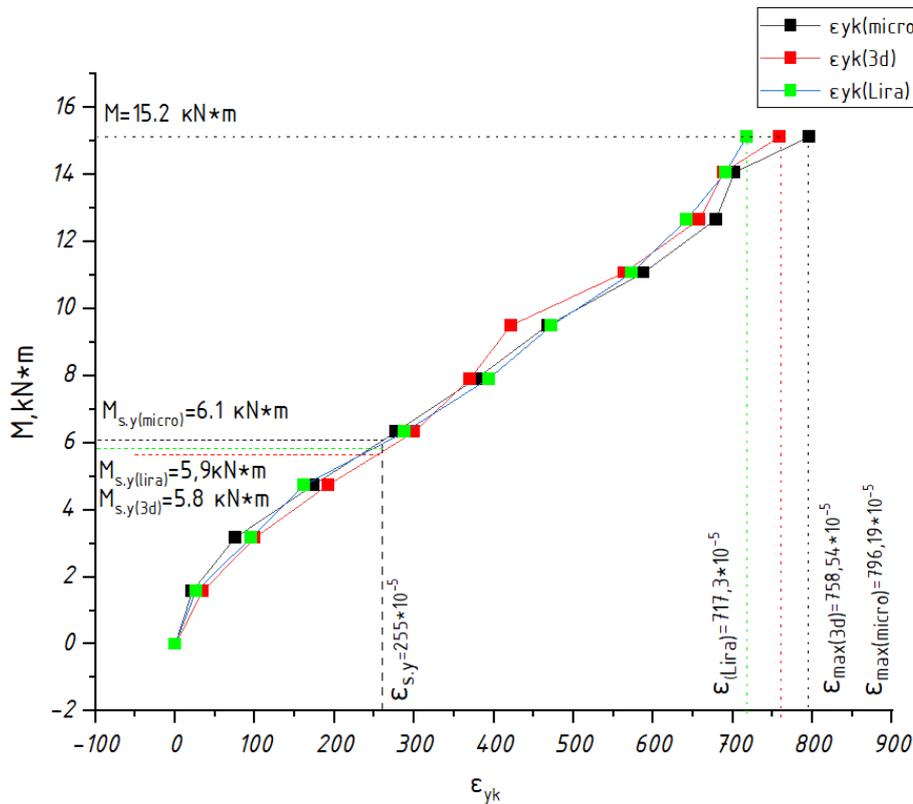
**Fig. 4.** Comparative graph of reinforcement strains  
**Рис.4.** Порівняльний графік деформацій арматури

The analysis of the graphs makes it possible to determine the moment at which the yield strength of the reinforcement is reached for each method, as well as the maximum reinforcement strain values for each approach.

$M, \text{kN}\cdot\text{m}$	$\varepsilon_{yk}(\text{micro})$	$\varepsilon_{yk}(3d)$	$\varepsilon_{yk}(\text{Lira})$	3d vs micro	Lira vs micro
1,5825	21,63	34,5	25,85	59.5%	19.5%
3,165	75,19	99,78	95,25	32.7%	26.7%
4,7475	174,07	192,4	162,23	10.5%	6.8%
6,33	277,07	300,1	288,25	8.3%	4.0%
7,9125	378,01	370,28	393,9	2.0%	4.2%
9,495	467,6	421,2	472,65	9.9%	1.1%
11,0775	588,13	563,74	573,6	4.1%	2.5%
12,66	678,77	658,35	642,3	3.0%	5.4%
14,06	702,4	688,3	691,2	2.0%	1.6%
15,12	796,19	758,57	717,3	4.7%	9.9%

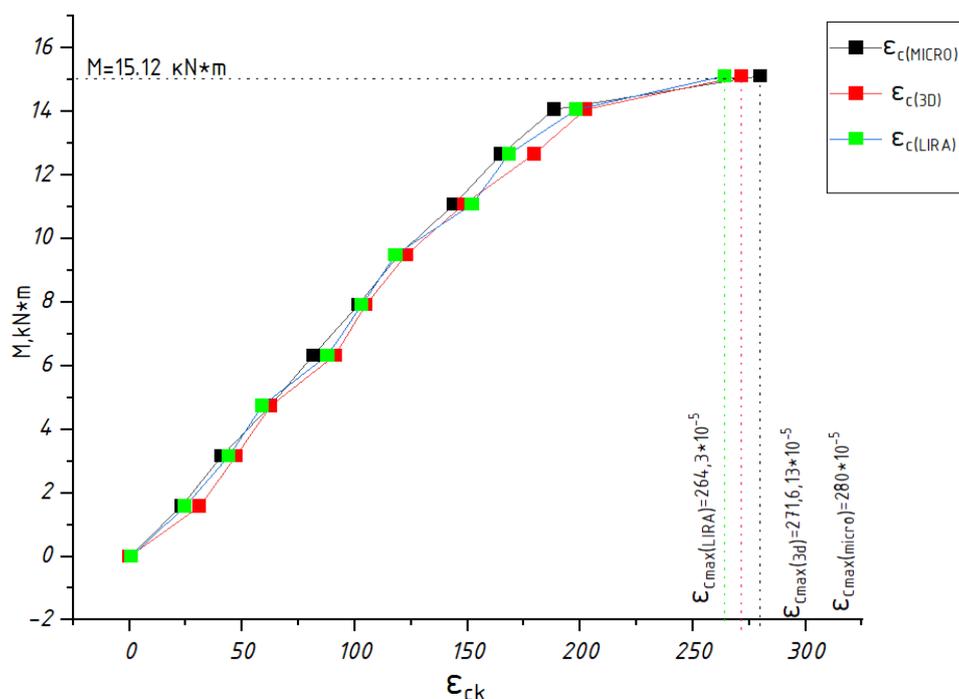
Figure 5 shows the strain graph of the compressed concrete zone near the undamaged edge.

**Fig. 5.** Comparative graph of concrete compression zone strains

M, kN*m	$\epsilon_{ck}(\text{micro})$	$\epsilon_{ck}(3d)$	$\epsilon_{ck}(\text{Lira})$	3d vs micro	Lira vs micro
1,5825	23	31,2	24,6	35%	7.0%
3,165	41	47,3	44,17	15%	7.7%
4,7475	62,5	62,8	58,83	0.5%	5.9%
6,33	81,5	91,2	87,88	11%	7.8%
7,9125	101,5	104,8	103,1	3.3%	1.6%
9,495	119,5	122,8	118,1	2.8%	1.2%
11,0775	144	148,4	152,1	3.1%	5.6%
12,66	165	179,5	168,4	8.8%	2.1%
14,06	188,5	202,4	198,33	7.4%	5.2%
15,12	280	271,6	264,3	3.0%	5.6%

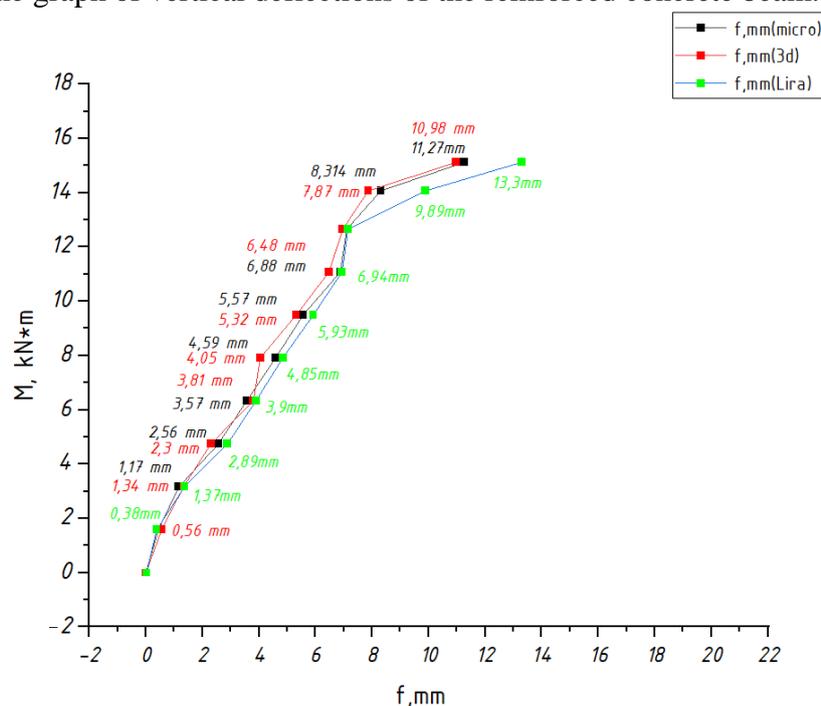
Figure 6 shows the graph of vertical deflections of the reinforced concrete beam.

**Fig. 6.** Comparative graph of vertical deflections

Before reaching physical failure, the theoretical deflection values exhibit slightly greater deviation from the experimental results.

This is due to the fact that the modeling assumes somewhat idealized conditions for the behavior of the reinforced concrete beam (Table 3). **Table.3.** Vertical deflections: experimental and numerical data

M,кН*м	f,mm (micro)	f,mm (3d)	f,mm (Lira)	3d vs micro	Lira vs micro
1,5825	0,448	0,56	0,387	25%	13,6%
3,165	1,176	1,34	1,37	13,95%	16,5%
4,7475	2,568	2,3	2,89	10,44%	12,4%
6,33	3,571	3,81	3,9	6,69%	9,21%
7,9125	4,592	4,05	4,85	11,8%	5,62%
9,495	5,57	5,32	5,93	4,49%	6,46%
11,0775	6,88	6,48	6,94	5,81%	0,87%
12,66	7,11	6,97	7,15	1,97%	0,56%
14,0666	8,314	7,87	9,89	5,34%	18,6%
15,121	11,27	10,98	13,3	2,57%	18,1%

Vertical deflections in the damaged zone reached 11.27 mm (according to micro-indicators), which correlates well with the calculated values of 10.98 mm (3D DIC) and 13.3 mm (LIRA model). The maximum reinforcement strains were  $280 \times 10^{-6}$ , while horizontal deflection exceeded 7 mm. The

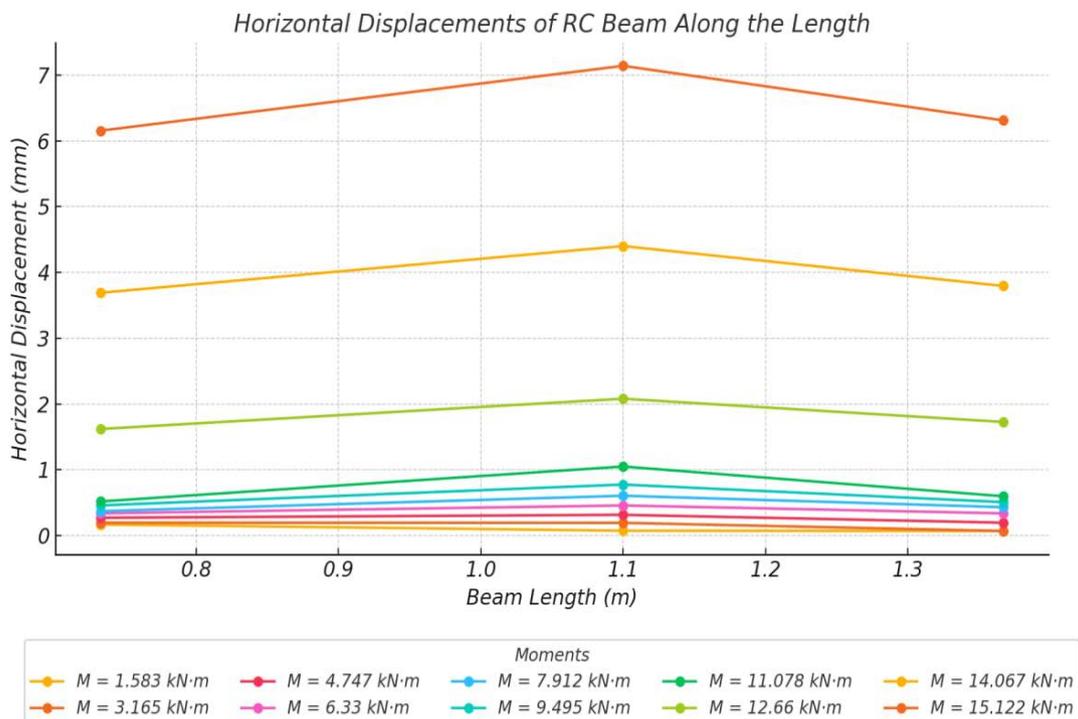
Figure 7 presents the results of horizontal displacements.

**Fig. 7.** Horizontal deflections of the specimen along the beam length

The results show that horizontal displacements gradually increase with increasing load, with the largest values observed in the damaged zone (Table.4).

The lateral displacement of the beam indicates a shift of the neutral axis and the beam's behavior under skew bending conditions.

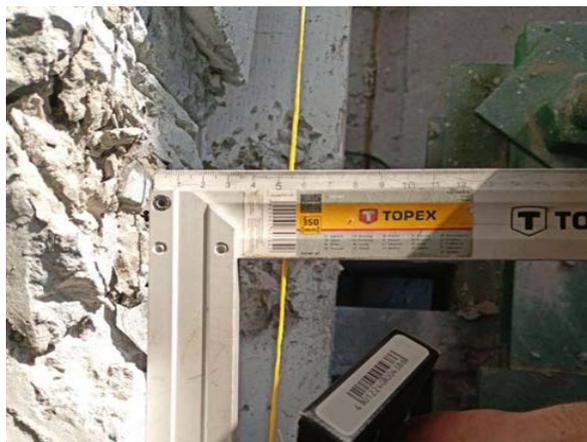
The experiment recorded the presence of a residual deflection of the reinforced concrete beam after unloading (Fig. 8).

This residual deflection indicates irreversible changes in the structure of both the concrete and the reinforcement. Such residual deflections are important for assessing the

**Fig. 8.** Residual horizontal deflection  
**Рис.8.** Залишковий горизонтальний прогин

remaining load-bearing capacity of the structure after loading.

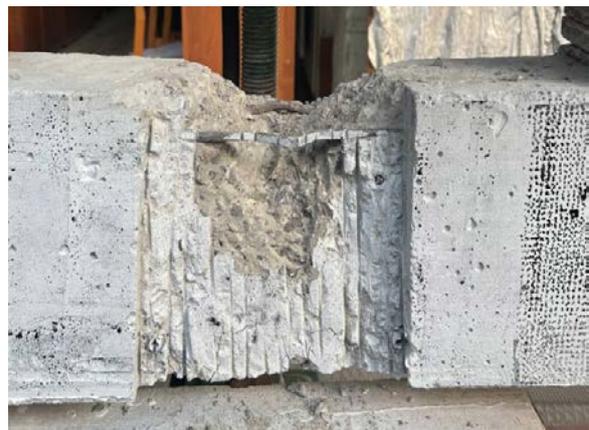
A visual inspection of the specimen after testing also confirmed the presence of residual vertical deflection in the loading zone, which correlates with the measurement results

**Fig. 9.** View of the reinforced concrete beam after the experiment from the damaged side.  
**Рис.9.** Вигляд залізобетонної балки після експерименту із сторони пошкодження
