ANALYSIS OF SOME CASES RESIDENTIAL BUILDINGS DESTRUCTION AS A RESULT OF COMBAT ACTIONS

Abstract. The problem of residential infrastructure destruction as a result of the aggression of the Russian Federation is very relevant in Ukraine. If houses are subject to major repairs, they may have various damages, from major to relatively minor. Also, during inspections, the consequences of long-term fires that were not extinguished and the structures from the fire have completely lost their load-bearing capacity are often found. Such damages can be severe and localized within the framework of the frame cells, apartments, rooms on the lower floors, which makes it impossible to carry out radical actions, such as complete replacement. For example, replacing structures could require dismantling the floors above, which is not advisable.

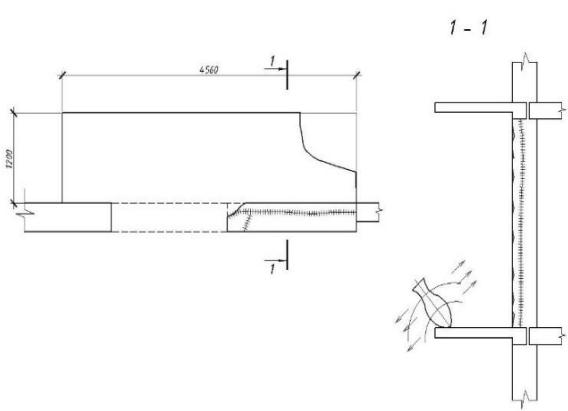
The damage diagram is shown in Fig. 1. Photo in Fig. 2. Thus, as a result of the impact

of a mortar shell, a balcony slab was damaged. A corner was knocked out and destroyed in the slab, and at the same time, deep cracks were visible in the partition wall, in which this slab was pinched from the side of the affected corner. The nature of the cracks development, depth, and area of distribution were not visible at first glance. The facade insulation on the wall was also destroyed and the wall surface itself was damaged by blast fragments. At the same time, beacons were installed on the cracks, which showed further progression of the crack opening, as a result of which the company operating the building decided to install supports within the opening.

Fig. 1 Diagram of structural damage due to a mortar shell hitting a balcony slab

When attempting to pull the wall together with a metal clamp, it was discovered that it had delaminated across the entire height and area within the 7th floor and as a result required complete re-laying. This was accomplished with sequential dismantling, re-supporting, and re-laying of the masonry in sections.

In the final conclusion, such destruction can be considered typical when ammunition hits the balcony slab and it can lead to progressive destruction of the wall within the upper floors with the collapse of the slabs. In the described case, it was fortunate that the impact occurred on the penultimate floor and the load on the laminated partition was not large and measures for temporary support were taken in time.

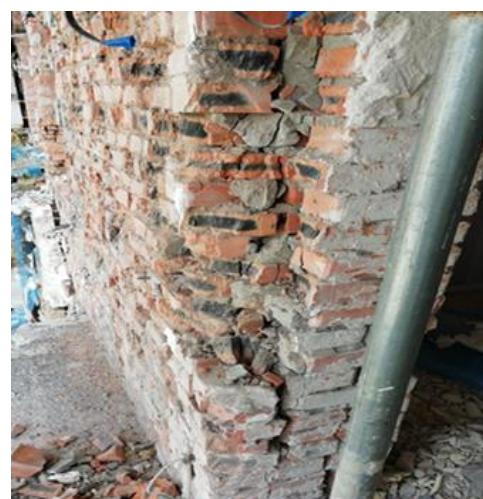
Fig. 2 Appearance of the crack from the end of the wall.

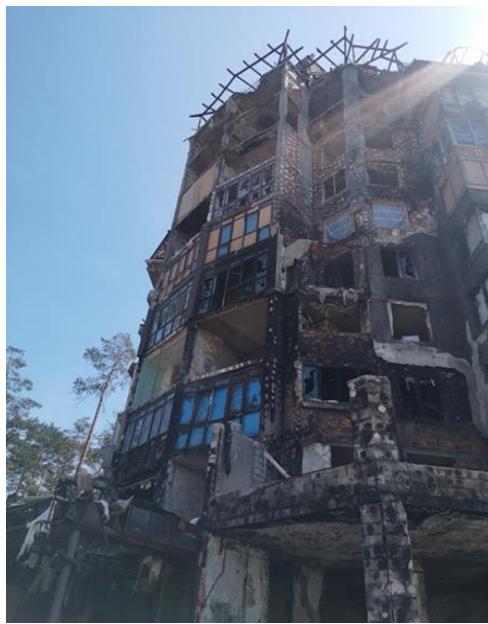
Thus, a multi-storey residential building in the city of Irpin was located in a combat zone and suffered massive damage. The exterior of the building is presented in Fig. 3.

Fig. 3 Exterior view of a section of a building with a monolithic reinforced concrete frame that was damaged during hostilities. Photo by V. Nuzhnyi

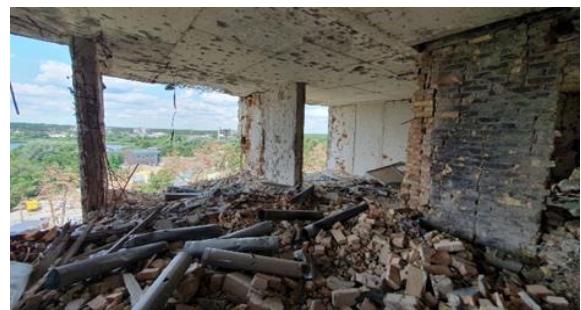
In this building, the consequences of the arrival of shells, mortar shells were observed, which caused both mechanical damage and long-term fires. The roof with the attic floor was completely destroyed and all the damage was localized - within the apartments, rooms. The total amount of damage did not exceed 30..35%. Therefore, it was decided to save the house and carry out its major repairs. The structures of the corner section, which is presented in Fig. 3, were especially damaged. Starting from the 6th floor, the frame elements had massive damage (see Fig. 4, 5, 6, 7).

Fig. 4 External view of the damage within the floor. Photo by V. Nuzhnyi

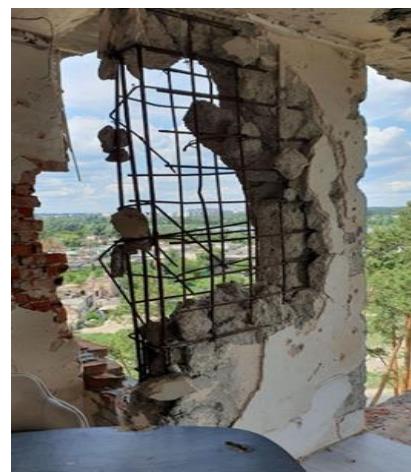
Fig. 5. Pylon hit by a projectile. Photo by V. Nuzhnyi

making this decision was the significant damage to the columns and pylons (see Fig. 5 and 6). With such crushing of the concrete with the exposure of the reinforcement, the integrity of the structure is completely lost. There are also distortions of the floors located above, which, even if they are relatively intact, require dismantling.

After damage analysis, it was considered appropriate to dismantle the building frame, starting from the 6th floor. The main factor in

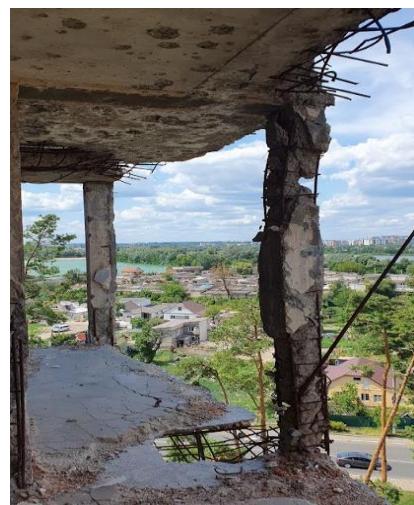
Fig. 6 Damage to the frame slab and columns. Photo by V. Nuzhnyi

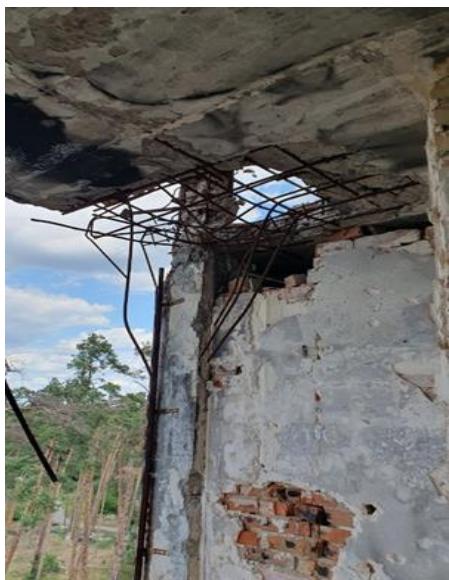
Fig. 7 Damage to the frame plate from Fig. 6, bottom view. Photo by V. Nuzhnyi

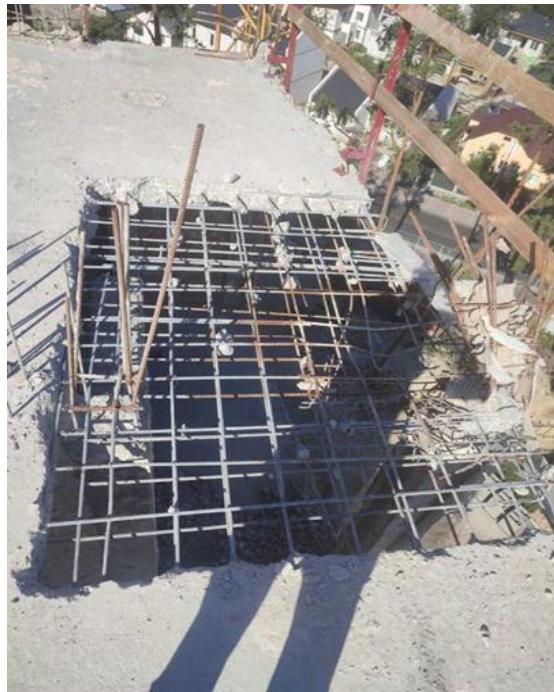
Some damage to floors from shell and mine impacts leads to significant damage around it, which must be taken into account when designing major repairs. Thus, the floor penetration shown in Fig. 6 and 7 was cleared of splintered and cracked concrete around it, and as a result, the damage zone turned out to be almost equal in area to a cell (see Fig. 8).

Fig. 8 Cleared impact zone from Figs. 6 and 7, which nearly corresponds to the dimensions of a structural bay. Photo by V. Nuzhnyi

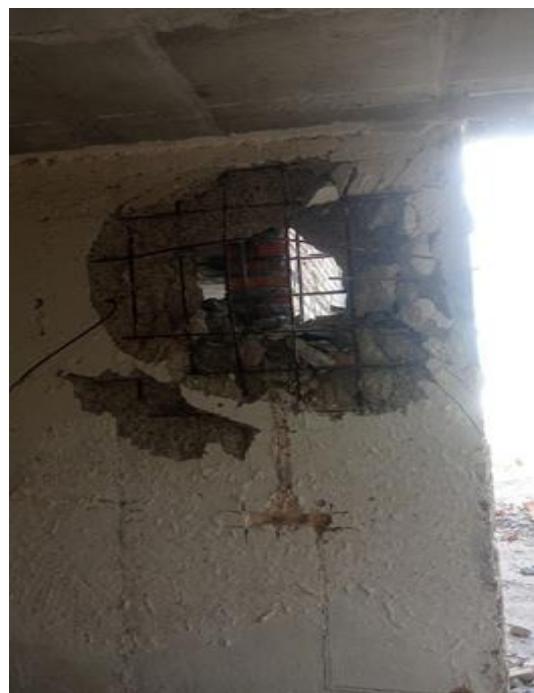
Similarly, it is possible to classify less extensive damage at first glance, for example, through-hole damage to a pylon by a projectile, which leads to a 50..60% loss of strength (see Fig. 9). Moreover, any through-hole damage is characterized by a small hole at the entrance and large-scale chipping of concrete with destruction of the reinforcing frame at the exit.

Fig. 9 Through-hole damage to the pylon. Photo by V. Nuzhnyi

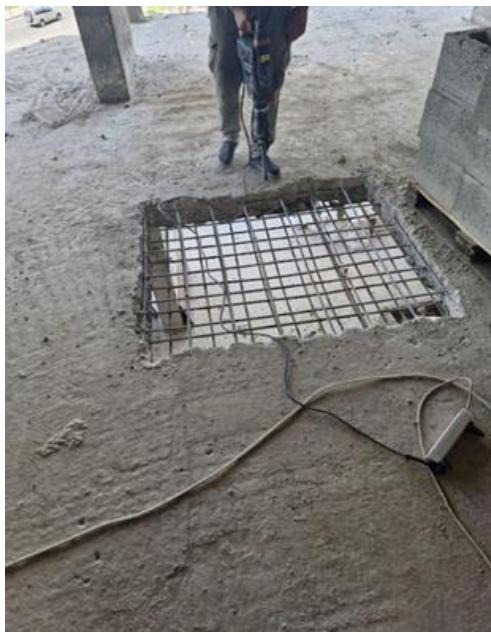
An example of clearing a small hole from a small-caliber projectile or mortar in a ceiling with a total diameter of up to 150 mm can also be given. Despite the fact that such an impact did not cause significant deformations and damage to the reinforcing frame at first glance, the concrete damage zone was about 1x1 m and had to be cleared (see Fig. 10).

Fig. 10 Cleaning damaged concrete after a pinpoint hit by a small-caliber projectile. Photo by V. Nuzhnyi

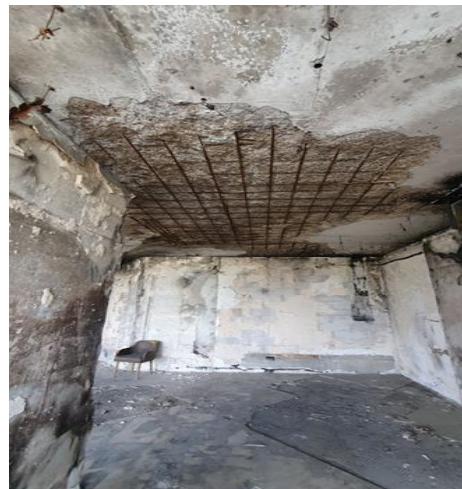
The last described phenomena are characteristic both for floor slabs and for vertical monolithic reinforced concrete elements - diaphragms, pylons. The consequences of typical large-scale fire damage to floor sections are shown in Fig. 11 and 12.

Fig. 11 Effects of fire on floor slab. Photo by V. Nuzhnyi

The bearing capacity of such structures cannot be assessed in any way according to [23, 24, 25], since the structural integrity of the calculated cross-section is completely destroyed. The picture is complicated by the fact that such damage is not massive in nature but is localized within certain cells (where there were rooms in which the fire occurred, and there were no neighboring ones). Thus, demolishing the house is not economically feasible, and replacing the floor in the conditions of the existing frame is complicated by the impossibility of complete replacement and re-supporting of the columns.

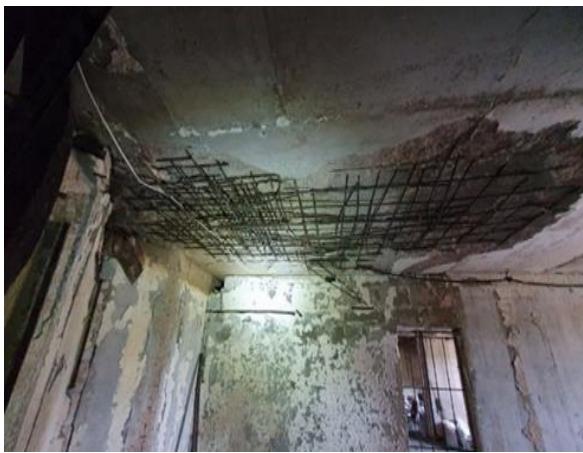
Fig. 12 Complete destruction of the working reinforcement in the ceiling after prolonged exposure to fire. Photo by V. Nuzhnyi

Fig. 12 shows the complete destruction of the reinforcing mesh of the basement floor as a result of a multi-day fire in the basement, where office premises were located. When clearing the affected areas of concrete, it turned out that the cross-section of the slab had completely lost its strength throughout. As a result, a relatively large section of the floor was removed (see Fig. 13).

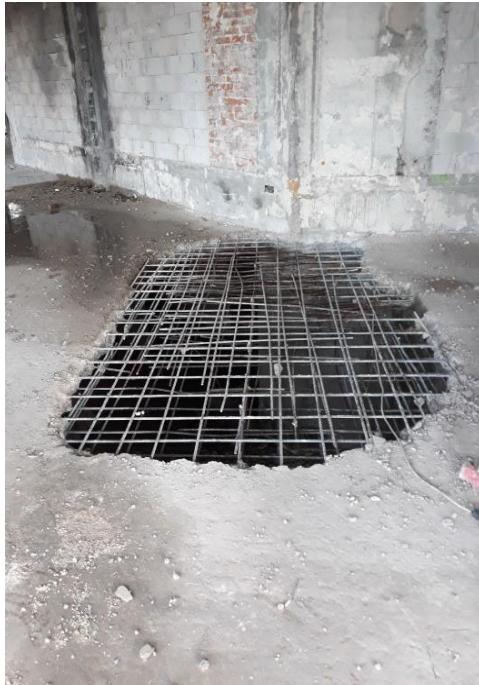
Fig. 13. Cleared area of the ceiling after the fire, shown in Fig. 12. View from the upper floor. Photo by V. Nuzhnyi

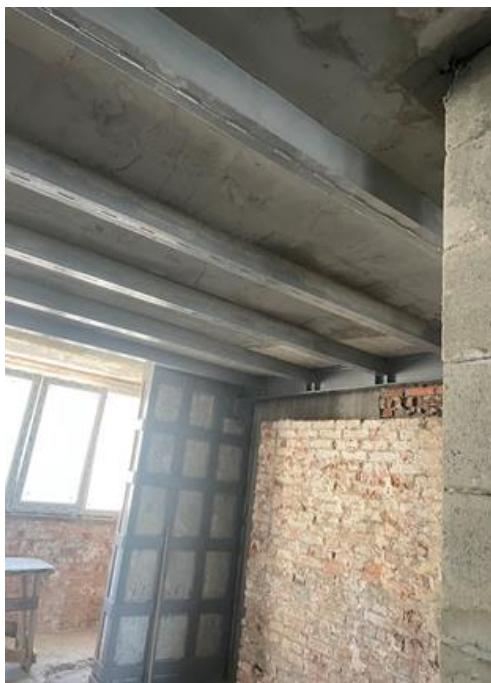
Fig. 14 Reinforcement of the floor slab after a fire by adding steel beams. Photo by V. Nuzhnyi

The described destructions are complex from the point of view of capital repairs. Replacing floors, re-supporting new ones on existing columns is a rather complex and sometimes impossible task. Its complexity lies in the impossibility of restoring the adhesion of the new part to the existing one, the impossibility of restoring the support prisms of the thrust on the columns that continue to the higher floors, etc. Therefore, the simplest of the proposed methods of repairing such floors is to introduce steel brackets on the columns and arrange steel beam cells on them using welded I-beams and closed double-walled sections, paired I-beams, etc. (see Fig. 14). The main condition for such a beam system is a small height. Provided that the beams are made with a height of up to 140..150 mm and they are covered with a plasterboard ceiling, the height and functional purpose of the room do not significantly decrease.

When performing spot repairs on the scale of the entire frame, where it is not advisable to dismantle the floors located above, it has been shown that it is advisable to use reinforcement by introducing steel beam cells.
