TECHNOLOGY FOR RESTORING STRUCTURES OF MULTI-APARTMENT PANEL BUILDINGS DAMAGED BY MILITARY ACTIONS

Abstract. This paper addresses the problem of restoring the load-bearing structures of multi-apartment large-panel residential buildings damaged as a result of military actions, based on a real case study. The nature of structural damage caused by blast effects is analyzed, including the displacement and destruction of wall panels, loss of stiffness in structural joints, damage to floor slabs, and disruption of the building's spatial behavior. It is shown that the main hazard is associated not only with local structural failures, but also with the loss of composite action between the elements of the structural system.

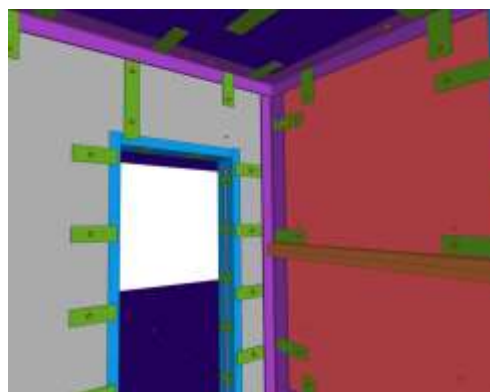
Fig. 21 Three-dimensional model of the structural strengthening of Apartment No. 40
Рис.21 Тривимірна модель підсилення конструкцій квартири №40

This helps to position new structural elements more accurately exactly where they are required (Figs. 21, 22).

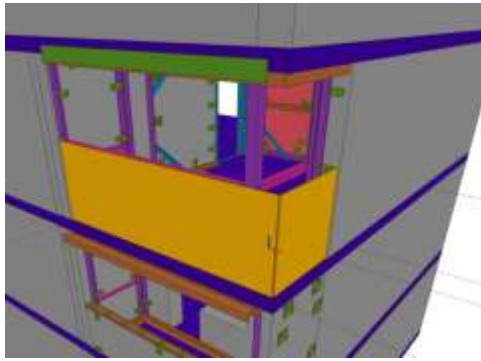
Fig. 22 Three-dimensional model of the structural strengthening of the balconies
